# RESTORATION OF HISTORIC STAINED GLASS IN THE CZECH REPUBLIC

## Jan Černohorský

The Church of St. Nikolaus is located in the historical center of Mikulášovice (Nixdofr) in the Šluknov region in north Bohemia. The first mention of the church dates back to the 15th century. (1445). The current building dates back to 1750-1751. The church has undergone a reconstruction in the last 10 years including 3 stained glass windows. First was restored the geometric stained glass window in the front facade of the church and then a pair of windows in the presbytery. The window in the front was restored in 2004, windows in the presbytery during 2006 and 200

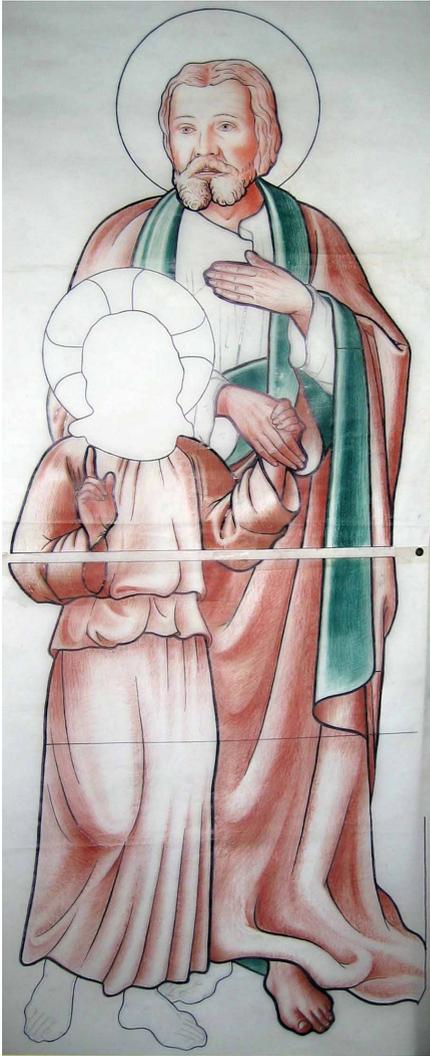
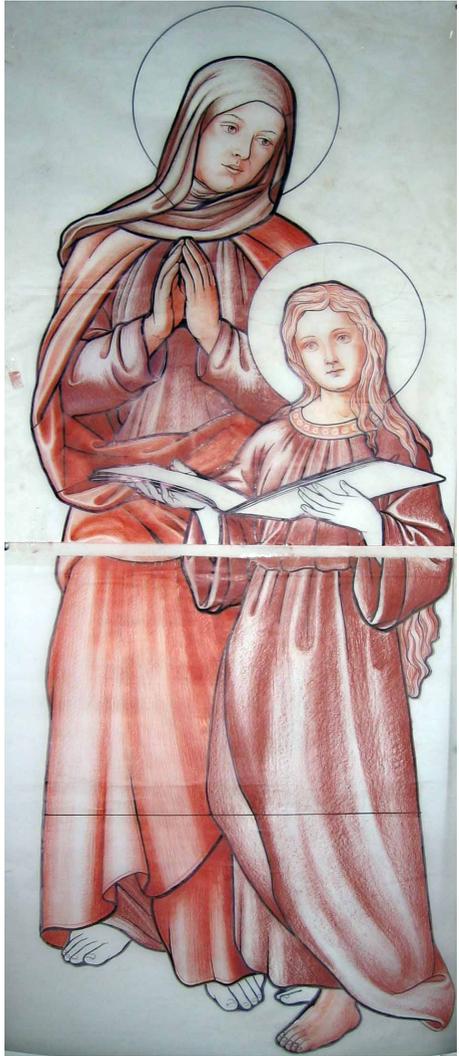
Stained glass in the presbytery was greatly damaged. Damaged glass and losses were a substantial part of the stained glass. Only the torso was left out of the main figural part. Large damages included also the whole faces of the figures. A large part of the stained glass area had to be reconstructed unfortunately without the possibility to come out of some archive image documentation.

Thus, the complete restoration of the stained glass was entered. Restoration included disassembly the glass from the original damaged lead network, cleaning of the glass pieces, adding paintings, and replacing missing and broken parts by making copies. The graphic reconstruction of the original motif was based only on preserved parts of the characters. Unfortunately there was no archive graphic documentation available. Before completing the add-ons, the design was approved by representatives of the church, the city, and the NPU staff. Replenishment of the stained glass was done by adding glasses produced by the same technology using glass firing painting (enamels). Stained glass was recreated in a classic way. The color is determined by the color of the glass, the painted motif is made up of black contour and dark shading, which tones darkens and lightens the color of the glass. The yellow details were made by silver stain.

The stained glass was based on a new lead network that matches its original came profile. The stained glass windows were reinstalled back to its original place, including renovation of metal structures and external protective bars.
