HENRY MAGUIRE, ANN TERRY

**THE WALL MOSAICS IN THE CATHEDRAL AT POREČ:  
ISSUES OF RESTORATION**

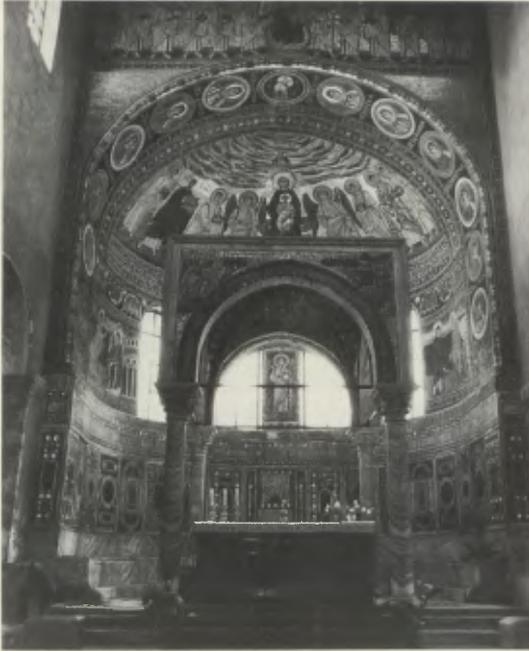
1. Main apse, basilica of Eufrasius.

This paper reports on a collaborative study of the wall mosaics of the cathedral in Poreč (fig. 1). These mosaics date to the mid-sixth century, but were restored in the late nineteenth century. Our study is based both on recently found restoration documents (Terry and Muhlstein 1998; Muhlstein 2002), and on examinations of the mosaics from scaffolding during three campaigns (1997, 1999, 2000). Our method was to make tessera by tessera studies of small, selected areas, or sondages, involving minute examinations of cubes, setting beds and setting techniques. We identified five phases of work in the mosaics (sixth century, eighteenth century, two in the late nineteenth century, and twentieth century repairs), and we also made discoveries about the mosaic making of these phases. We published three preliminary reports, and are currently producing a final report (Terry and Maguire 1998, 2000, 2001).

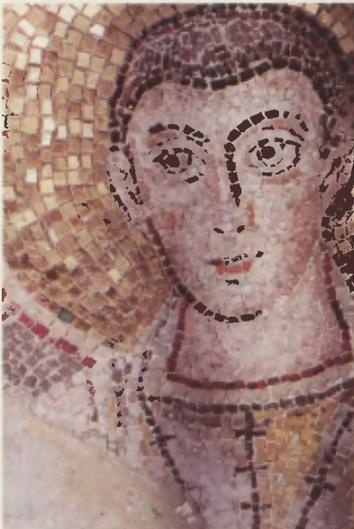
2. Head of Damian, north apse.

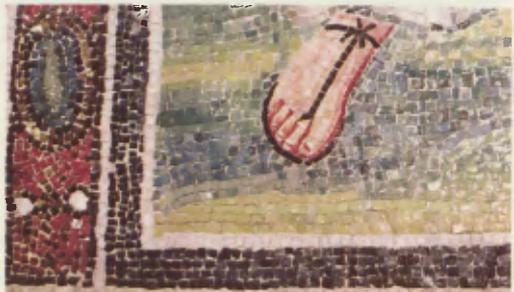
3. Left foot of Gabriel from the Annunciation.

also from Bornia's later restoration. In addition to leaving very obvious sutures in inappropriate places (Terry and Maguire 1998: fig. 12), a large percentage of the colours of tesserae used by Solerti are found nowhere else in the mosaics, particularly the greens (fig. 3). Moreover, the type of glass used was more opaque, dense and much more highly glossed than most of the glasses used in the later restoration. Solerti also cut tesserae into long rectilinear shapes, which, when grouped tightly, mimic the look of brickwork. Solerti set tesserae together very closely, so that one does not always see very much of the setting bed (fig. 3). Other tell-tale clues involve cutting tesserae into shapes to fit a design, rather than fitting pre-cut cubes into a design. In the north acanthus cup, Solerti fashioned the beige tips of the leaves into claw-like points by curving one side of a triangular cube. As the acanthus cup on the south side demonstrates, the original mosaicist used either triangular cubes set on end at the tip of a leaf, or square cubes placed obliquely. Furthermore, Solerti also cut tiny triangular cubes and fit them in intricate patterns to fill interstices, where the sixth-century mosaicist would have used a square cube at an angle, or a simple triangular cube.

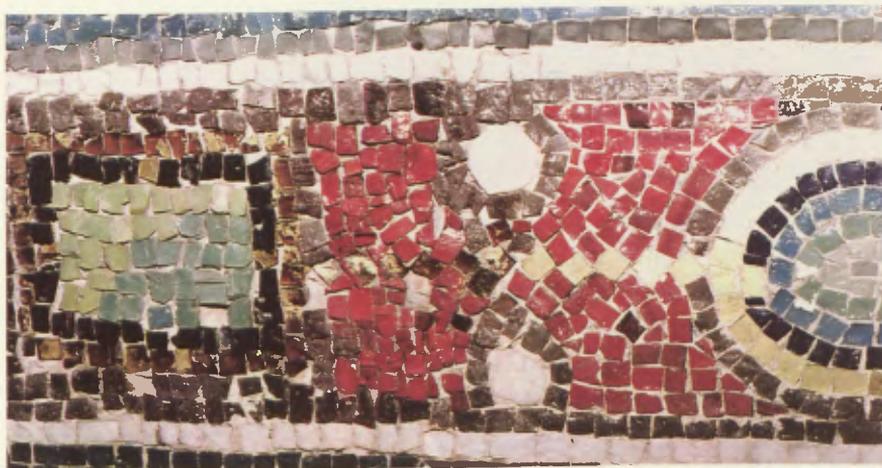
4. Red border beneath the Visitation, detail.

The second part of this paper will look at selected details of the mosaics to see how much is original and how much is nineteenth century work. This is the puzzle set to us by the clever late nineteenth-century restorer. First, we will explain briefly how we were able to distinguish the two phases, sixth and nineteenth century. The clearest indicators were the tesserae themselves. We can see the distinctions in fig. 4, which reproduces a section of the jeweled band beneath the Visitation. The space between the jewels is punctuated by two discs of white marble. Nearly all of the tesserae in the red jewelled band to the left of the white discs are old, while nearly all those to the right are new. The old cubes are irregular in shape, have uneven surfaces, and are more varied in hue. The new red tesserae, on the other hand, are more evenly cut, have crisper edges, and show less variety in hue.

time. The old setting technique is markedly irregular. The tesserae vary in height, giving the mosaic fabric a pronounced rippling surface. The cubes are often set askew, or at slight angles to each other, which, together with the odd shapes of many original tesserae, can create a jumbled appearance. Another distinctive feature of the old tesserae is that they now project well above the surface of the mortar. Many of these features can be seen in fig. 4, at the left side of the jeweled band, where the setting of the cubes is comparatively irregular. The right side, by contrast, is much more even. We can also see, especially in the greens making up the rectangular jewel, how the original tesserae project a good deal above the level of the setting bed.

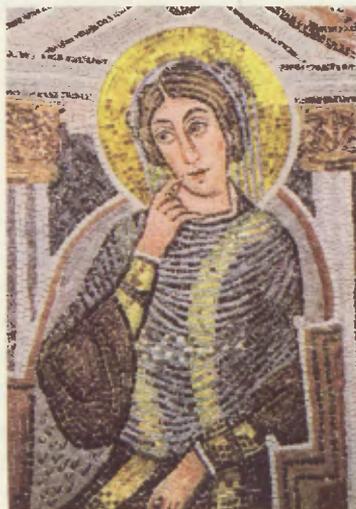
6. Virgin of the Annunciation.

One of the most anomalous features of the present mosaics is found in the Annunciation which, as we have found from the documents, was located in one of the most extensively remade sections of the apse mosaics. In the mosaic of the Annunciation as it is now, the Virgin wears a long purple robe decorated with two broad gold bands that descend from her shoulders to her feet (fig. 6). Over this garment, she wears a curious light blue, diaphanous veil that covers the top and the back of her head and also the upper part of her body as far down as her waist. The question is, did the restorers invent this strange-looking veil, or is it authentic?

On examination, we found that the Virgin's hair contains mostly old tesserae set in a bed that is predominantly composed of the original poorly preserved grey plaster, except for a new patch at the upper right side. The blue tesserae that delineate the veil in this area are entirely old. The gold halo, on the other hand, is one hundred percent new, both in the cubes and the setting. The restorers often had to replace the old gold cubes, because these were especially subject to deterioration. The old gold cubes were a sandwich, with a layer of amber coloured glass beneath, a layer of gold leaf in the middle, and thin layer of translucent glass on top. In the course of time, most of the old gold cubes had lost their translucent top layers and their gilding, leaving only the brownish glass that had originally supported the gold leaf. So these old gold cubes were often replaced. The Virgin's robe is set with a mixture of old and new cubes, but once again the gold in the bands is entirely new. We also discovered that most of the pale blue glass cubes used to delineate the diaphanous veil in this region are original; there are also sections of the original plaster bed under the veil on the right side of her chest.

It appears, then, that the distinctive diaphanous veil is authentic, even though it is an unusual feature in depictions of the Virgin. It is tempting to see this garment as a reference to the famous veil of the Virgin that had been kept as a relic in the shrine of the Blachernai at Constantinople since the fifth century.
