# RESTORATION OF HISTORIC STAINED GLASS IN THE CZECH REPUBLIC

## Jan Černohorský

The Church of St. Nikolaus is located in the historical center of Mikulášovice (Nixdofr) in the Šluknov region in north Bohemia. The first mention of the church dates back to the 15th century. (1445). The current building dates back to 1750-1751. The church has undergone a reconstruction in the last 10 years including 3 stained glass windows. First was restored the geometric stained glass window in the front facade of the church and then a pair of windows in the presbytery. The window in the front was restored in 2004, windows in the presbytery during 2006 and 200

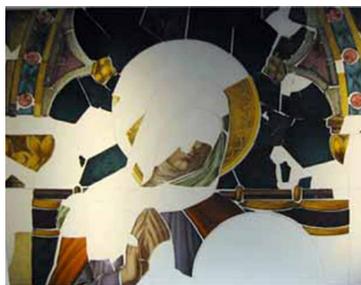
Stained glass in the presbytery was greatly damaged. Damaged glass and losses were a substantial part of the stained glass. Only the torso was left out of the main figural part. Large damages included also the whole faces of the figures. A large part of the stained glass area had to be reconstructed unfortunately without the possibility to come out of some archive image documentation.

Thus, the complete restoration of the stained glass was entered. Restoration included disassembly the glass from the original damaged lead network, cleaning of the glass pieces, adding paintings, and replacing missing and broken parts by making copies. The graphic reconstruction of the original motif was based only on preserved parts of the characters. Unfortunately there was no archive graphic documentation available. Before completing the add-ons, the design was approved by representatives of the church, the city, and the NPU staff. Replenishment of the stained glass was done by adding glasses produced by the same technology using glass firing painting (enamels). Stained glass was recreated in a classic way. The color is determined by the color of the glass, the painted motif is made up of black contour and dark shading, which tones darkens and lightens the color of the glass. The yellow details were made by silver stain.

The stained glass was based on a new lead network that matches its original came profile. The stained glass windows were reinstalled back to its original place, including renovation of metal structures and external protective bars.
